Residential Home Inspection Report for

City of Durham Neighborhood Stabilization Program

Inspection Address: 1017 Rosedale Avenue, Durham, NC 27702

Inspection Performed: January 15, 2010

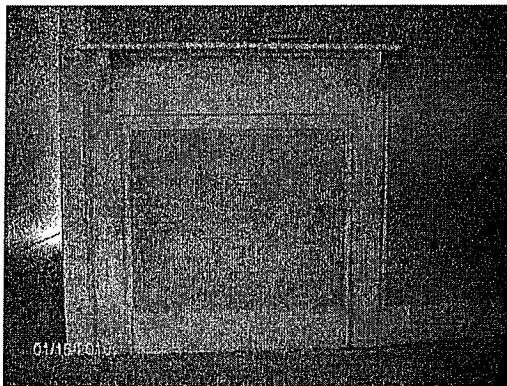
CHECKPOINT	CONDITION	COMMENTS
Air Ducts	Not Inspected	Access to attic not available. Diffusers on ceilings of rooms rusted and could not be operated as intended
Chimney	Serviceable	No structural problems observed with limited view from the ground using binoculars. No rain cap observed on neither
Flue Pipes	Not Inspected	Fireplaces blocked in front rooms
Heat Temp Check	Not Inspected	Property had no electricity
Return/Plenum		Located in front right room
Inside Fan	Not Inspected	Electricity not available
Condensation Drain	Serviceable	Located in closet of center bedroom appear to be intact
Outside Fan	Not Present	
Coil Fins	Serviceable	
Thermostat	Not Inspected	Located in front right room. No electricity to inspect operability. Simple Comfort@2200 model
AC Temp Check	Not Inspected	Electricity shut-off
Fireplace	Not Inspected	Both blocked/boarded

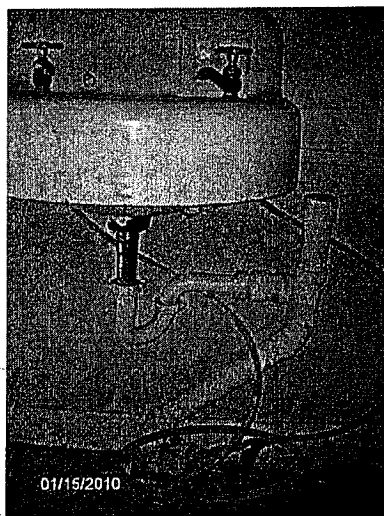
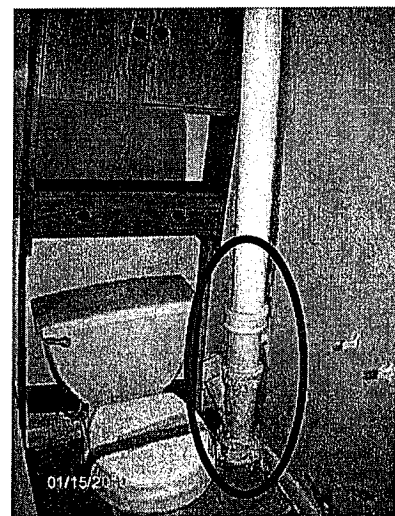
Water Supply Piping		PVC noted below sinks and washer area
Water Distribution Piping		PVC noted below sinks and bathtub
Water Heater Manufacturer/Model/Serial/Location		None could be located. Suspected to be in crawl space which was inaccessible to inspector
Water heater Manufacture Date		Not Inspected
Main Water Shutoff		Located on front yard at the right side of property adjacent to driveway
Sanitary Vent		Black Iron Pipe visible in rear bathroom
CHECKPOINT	CONDITION	COMMENTS
Vent Pipe system	Serviceable	Black iron pipe observed in rear bathroom
Drains	Not Inspected	Water supply shut-off
Water Function Check (Pressure)	Not Inspected	Water supply shut-off
Bathroom Fixtures	Needs Repairs	Fixtures damaged
Kitchen Fixtures	Not Inspected	Water shut-off
Water Heater	Not Present	May be located in crawl space which was not accessible to inspector
Fixture Connections	Not Inspected	No water supply available
Laundry Tub/ Whirlpool	Not Present

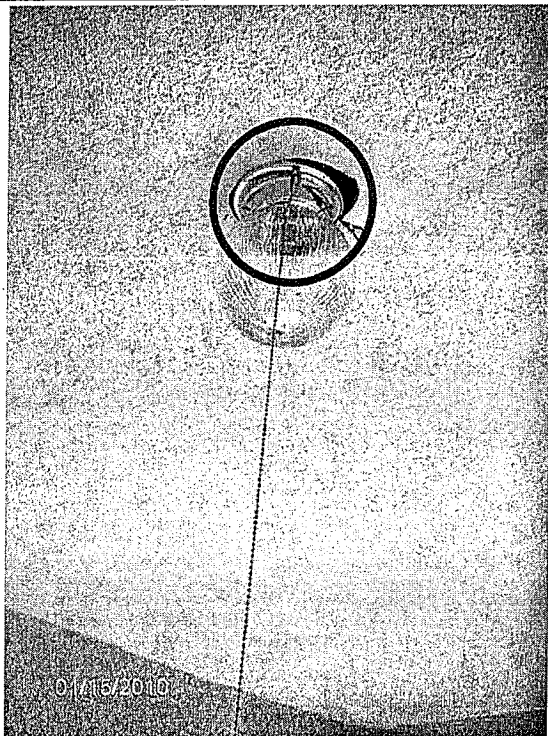
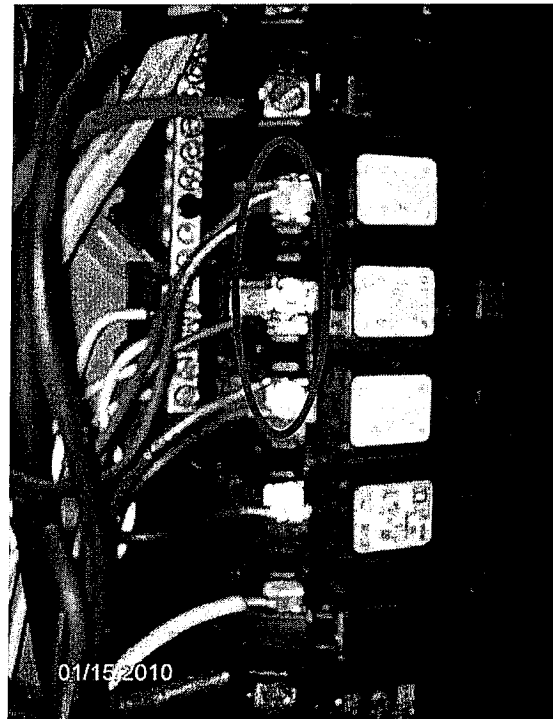
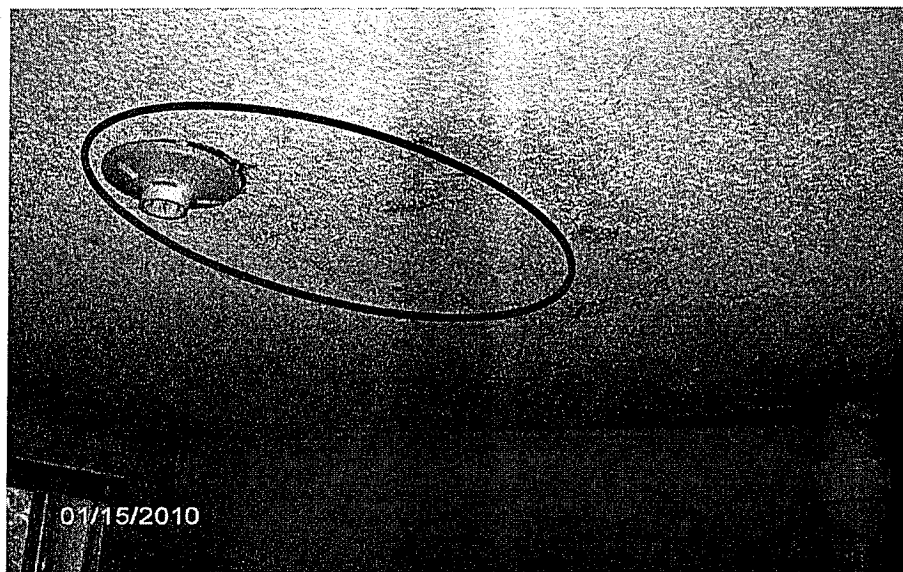
CHECKPOINT	CONDITION	COMMENTS
Service Entrance	Serviceable	Overhead located on left side of property. Ground rod wire connection separated
Service Ground & Location	Need Repairs	Cable damaged and separated from ground rod
Main Panel Box	Needs Repairs	Panel cover missing screws. No grounding bushings on knockouts
Breakers/Fuses	Needs Repairs	Improper wiring connections noted when panel cover removed in both breakers and neutral bus
HVAC Wiring	Serviceable	Limited view in the closet
Interior Wiring	Needs Repairs	Light fixtures missing and other improper connections noted in receptacles throughout interior. Water damage noted in close proximity to electrical fixtures
Kitchen Receptacles	Needs Repairs	GFCI plate painted and receptacles missing plate covers
Outside Receptacles	Not Present	
Interior Receptacles	Needs Repairs	Covers missing, GFCI coated with paint
Smoke Detectors	Needs Repairs	Battery low alarm noticed on both devices located on front bedrooms

electricity. Light fixture missing on rear bedroom. Water damage on ceiling light fixtures
Switches	Need Repairs/Not Inspected	Could not be operated as intended due to lack of electricity. Plates missing
Ceiling Fans	Not Present	One ceiling fan on floor of left front room. No others present
Door Bell/Ring	Not Inspected	Lack of electricity prevented from testing. Bell/ring box located on left front room

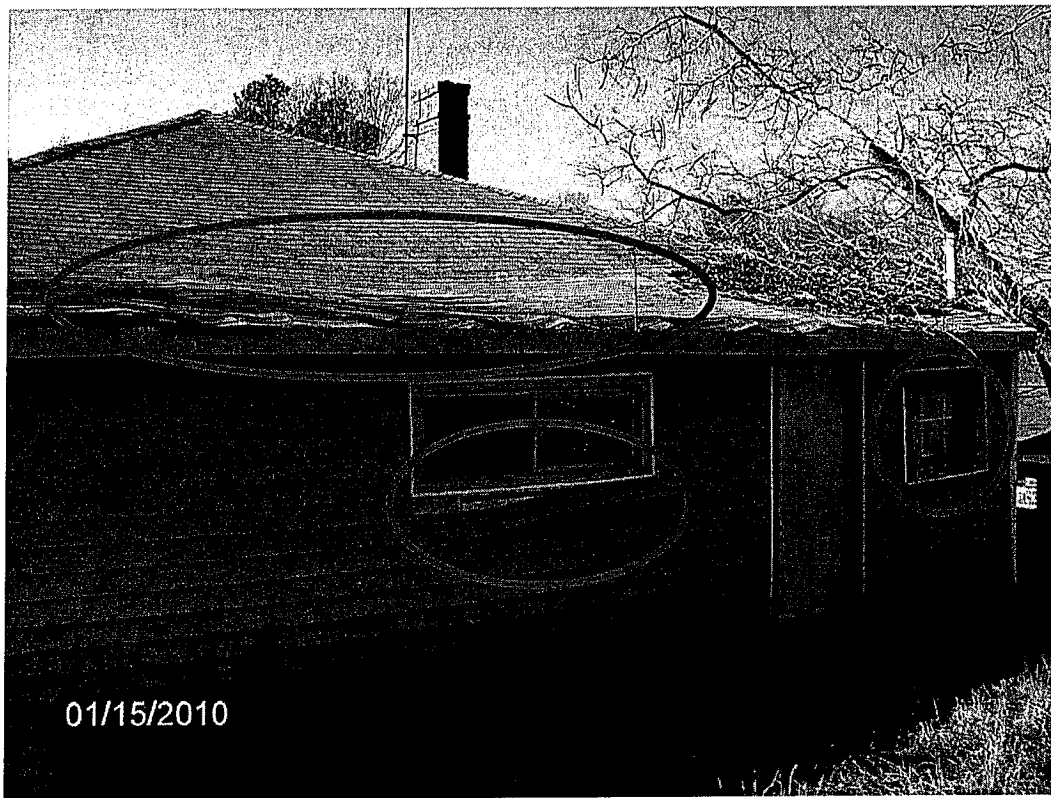
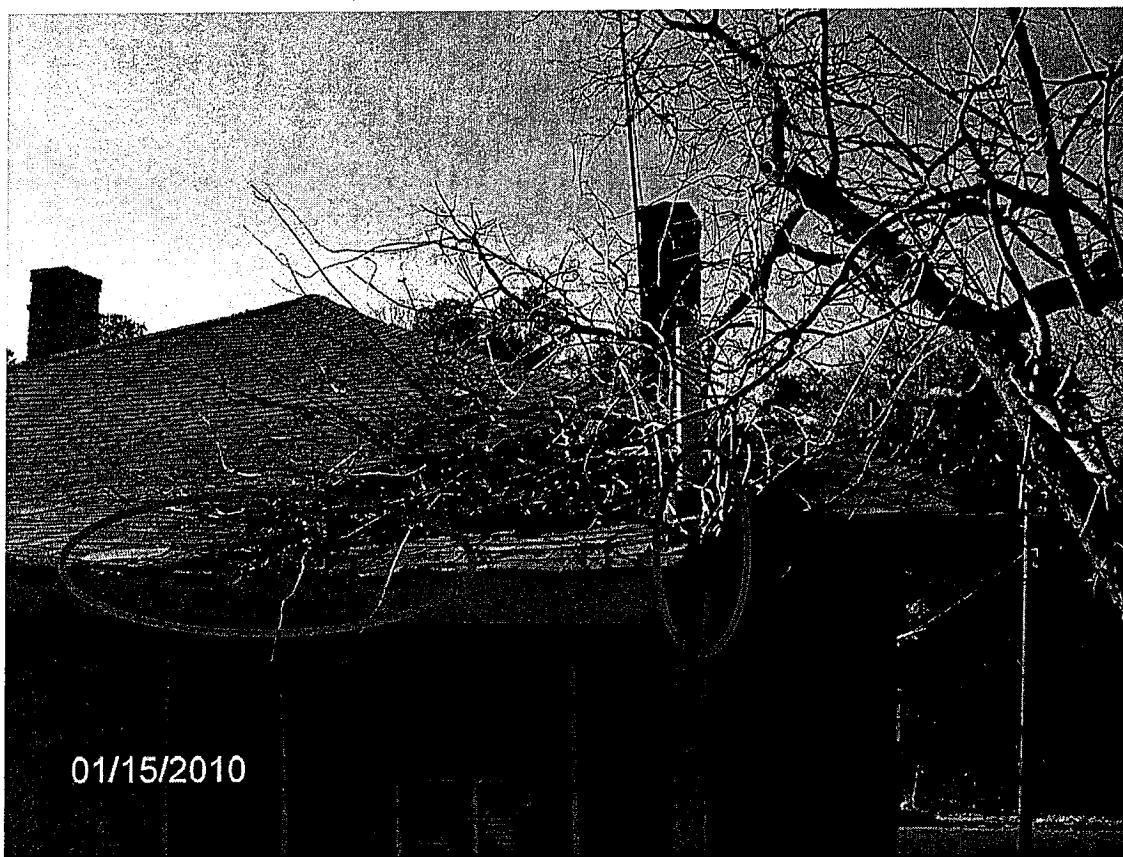
Foundation Type	Crawl Space	
Foundation Construction Method	Block/brick	
Foundation Observation Method	Visible on the outside as crawl space has been blocked/sealed to prevent tampering	
Wall Structure	Wood covered by paneling	
Ceiling	Wood panels covered with plaster system collapsing on bedrooms. Significant water damage and mold growth observed partly caused by apparent roof failure on rear of structure	
Floor	Uneven floors throughout living area may be indicative of understructure failure	
CHECKPOINT	CONDITION	COMMENTS
Foundation wall	Not Inspected	Access to crawl space blocked/sealed
Sill Plate/Band	Not Inspected	Access to crawl space blocked/sealed
Walks Driveways	Needs Repairs	Concrete driveway significantly deteriorated
Chimney Foundation	Not Inspected	Access to crawl space blocked/sealed
Ventilation	Needs Repairs	Insufficient for crawl space area
Roof Structure	Needs Repairs	Apparent failure observed on rear of property. Significant water infiltration observed on ceilings

Floor Joists	Not Inspected	Access to crawl space blocked/sealed
Vapor Barrier	Not Inspected	Access to crawl space blocked/sealed
Insulation below floor	Not Inspected	Access to crawl space blocked/sealed
Exterior Grade	Needs Repairs	Backyard slopes towards structure. Perimeter drip-line eroded
Retaining Walls	Needs Repairs	Walls adjacent to sidewalk in need of repairs and show significant cracks and deterioration
Ceilings	Needs Repairs	Areas in living space imminent failure or collapse. Mold observed throughout

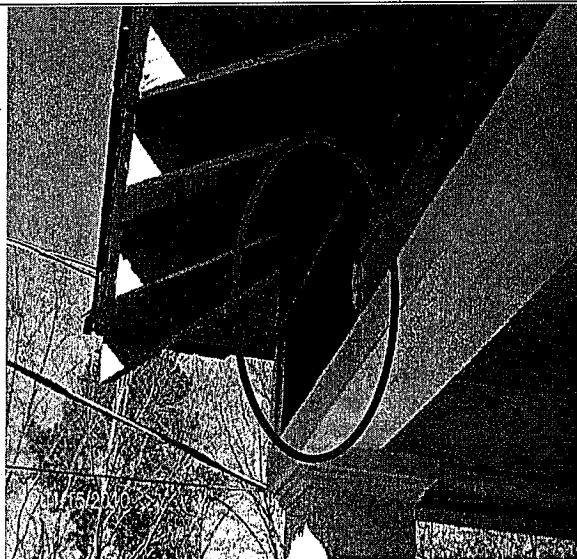
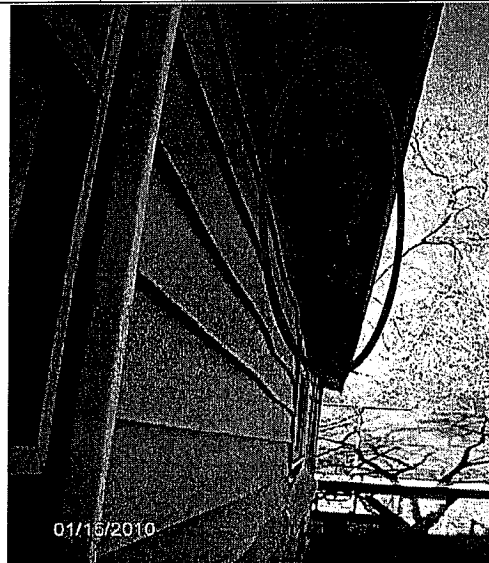
Wall Structure		Original wood frame with wood siding and wood trim
Cladding		Vinyl installed over wood. Vinyl broken in many areas
CHECKPOINT	CONDITION	COMMENTS
Siding	Needs Repairs	Vinyl siding and fasteners broken and missing
Trim Work/Eaves	Needs Repairs	Vinyl trim broken and eaves damaged by moisture
Windows	Needs Repairs	Windows could not be operated as intended and glass panes damaged/broken
Doors	Needs Repairs	Uneven floor prevent proper operation of doors. Locking devices missing. Front door panes covered by wood panel. Rear door blocked/boarded shut
Porch	Needs Repairs	Oriented Strand Board under synthetic floor cover observed damaged by water moisture
Screened-in Porch	Not Present	
Deck	Not Present	
Patio	Not Present	
Steps/Rails	Needs Repairs	Metal entry steps corroded
Carport	Needs Repairs	Concrete damaged and deteriorated
Garage Door	Not Present	
Vegetation	Needs Repairs	Vegetation growth observed in trim and entering cladding from foundation wall

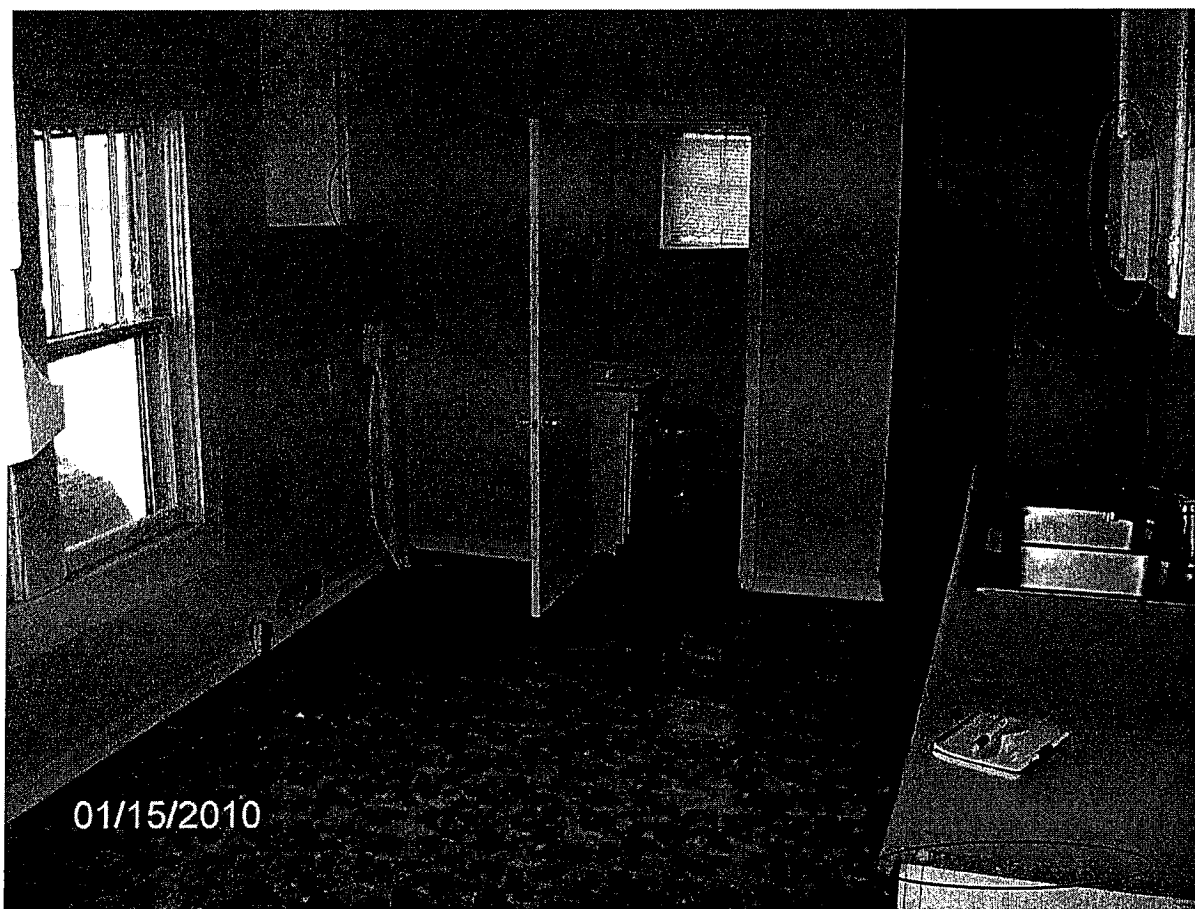
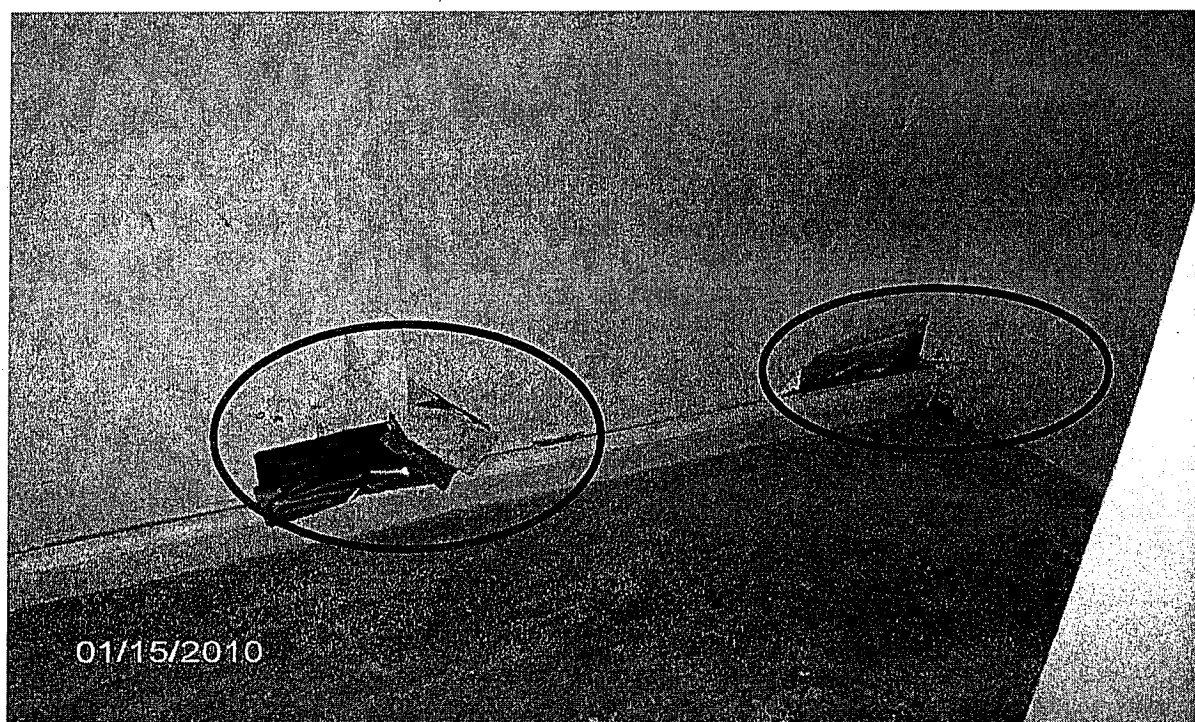
CHECKPOINT	CONDITION	COMMENTS
Walls	Needs Repairs	Moisture damage observed inside bathrooms and rooms
Ceilings	Needs Repairs	Plaster ceiling system failures and collapse observed
Floor	Needs Repairs	Uneven floors may be indicative of structural failures and possible cause of doors misalignments
Steps	Needs Repairs	Metal entry doors corroded
Railings	Needs Repairs	Porch left railing loose
Closets	Needs Repairs	Voids in closet walls and ceiling observed. Doors could not be operated as intended
Doors	Needs Repairs	Doors missing locking devices and could not be operated as intended
Windows	Needs Repairs	Windows could not be operated as intended and many panes damaged/broken
Cabinets	Needs Repairs	Cabinets loose from walls. Doors could not be operated as intended and knobs missing
Countertops	Needs Repairs	Damaged by moisture
Locks	Needs Repairs	Door locking devices missing or could not be used as intended

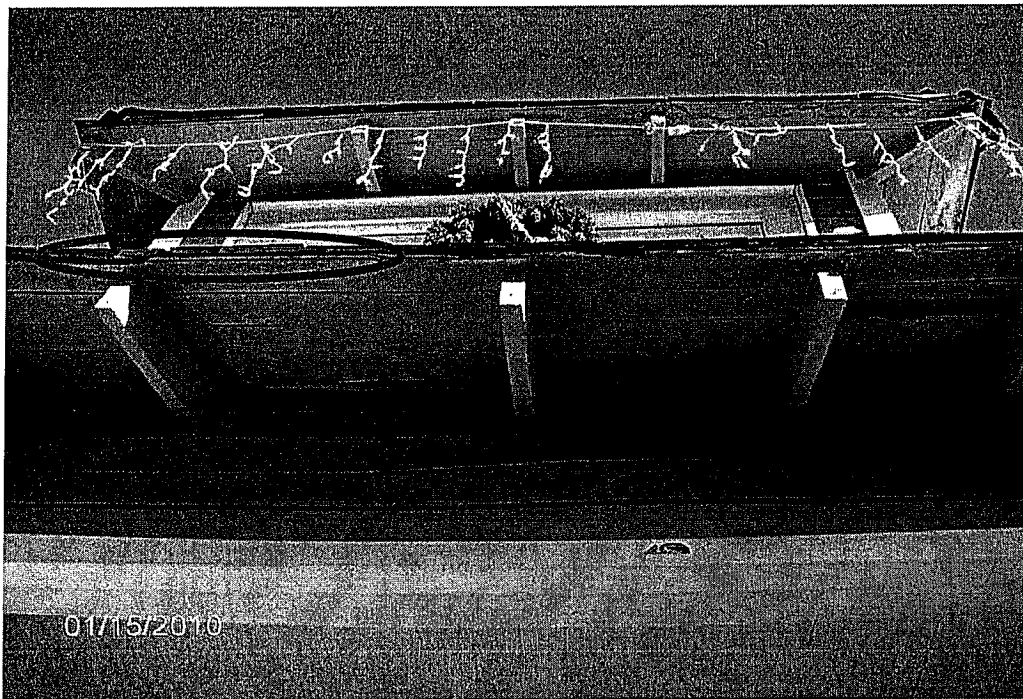
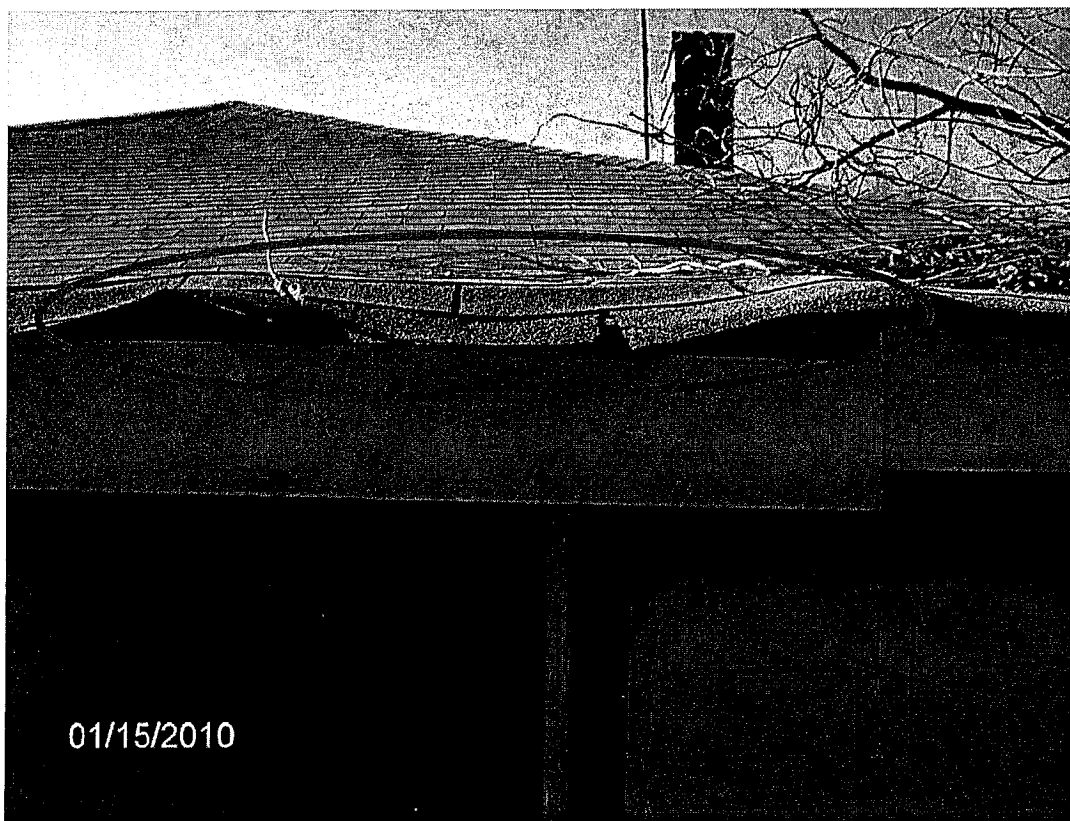
ROOF: Structural failure of roof system observed on rear of property and moist damage observed throughout the perimeter of the roof structure (sheathing, rafters and eaves). **This system of the property needs attention and shall be reviewed by a licensed professional in the business.**

CHECKPOINT	CONDITION	COMMENTS
Shingles	Needs Repairs	Partial collapse of roofing system on rear of property and deterioration may indicate past expected life of system
Flashing/Joints	Needs Repairs	
Vent Pipe		
Chimney		
Gutters and Downspouts	Not Present	
Attic Insulation	Not Inspected	
Attic Ventilation	None visible	
Joists/Rafter/Truss	Needs Repairs	Significant sagging and collapse of rear roof area may be indicative of structure failure
Sheathing	Needs Repairs	Wood sheathing damaged by moisture around the edge of the property/structure
Skylights	Not Present
